SWAN CANNING
RIVERPARK

Environmental Monitoring and Reporting Canning River Estuary ~ Weekly profile

by
Water Science Branch, Department of Water

Date: Tuesday 13th October 2015

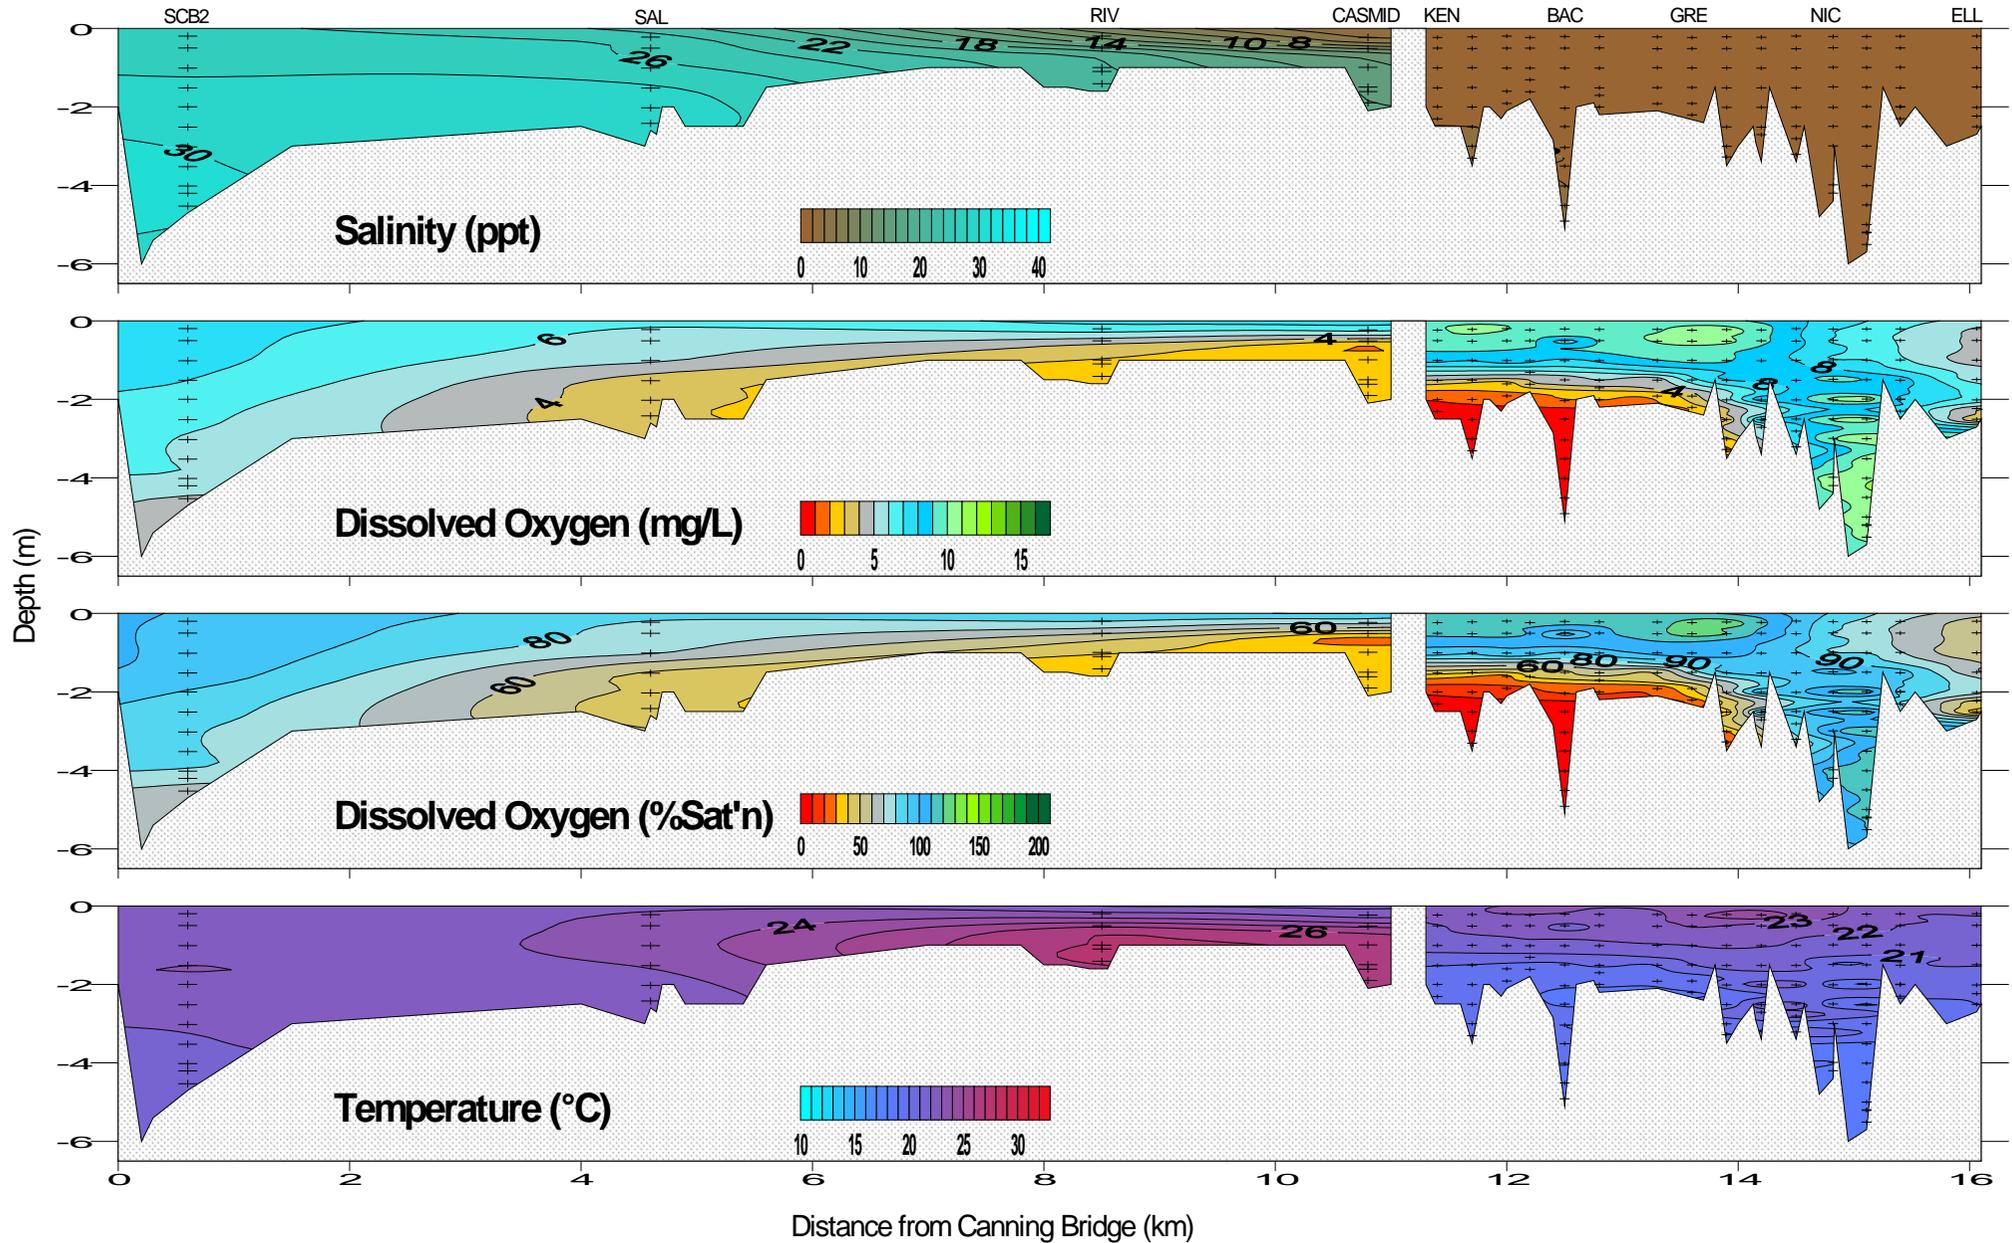
Canning River Estuary - Physical-chemical Profile - 13th October 2015

Canning Estuary (downstream of Kent St Weir): The Canning Estuary was saline throughout at SCB2 and SAL, brackish throughout at RIV and fresh to brackish at CASMID. Water was well oxygenated to low oxygen with hypoxic bottom water at RIV. CASMID showed a layer of hypoxic bottom water at a depth of 0.5 m. Water temperature ranged from 21.5 to 27.4 °C.

Lower Canning River (upstream of Kent St Weir): The lower Canning River was fresh throughout. Surface water was mostly well oxygenated. Bottom water had low oxygen at BACU300, was near anoxic at KEN and KENU300 and hypoxic at BACD500, PO2, GRE and KS7. Sites from NICD200 to PAC were well oxygenated throughout.
