# Swan Canning Estuary Water Quality Monitoring Project

## Weekly Water Quality Report

### Lower Swan Canning Estuary to Upper Swan Estuary

28<sup>th</sup> November 2022

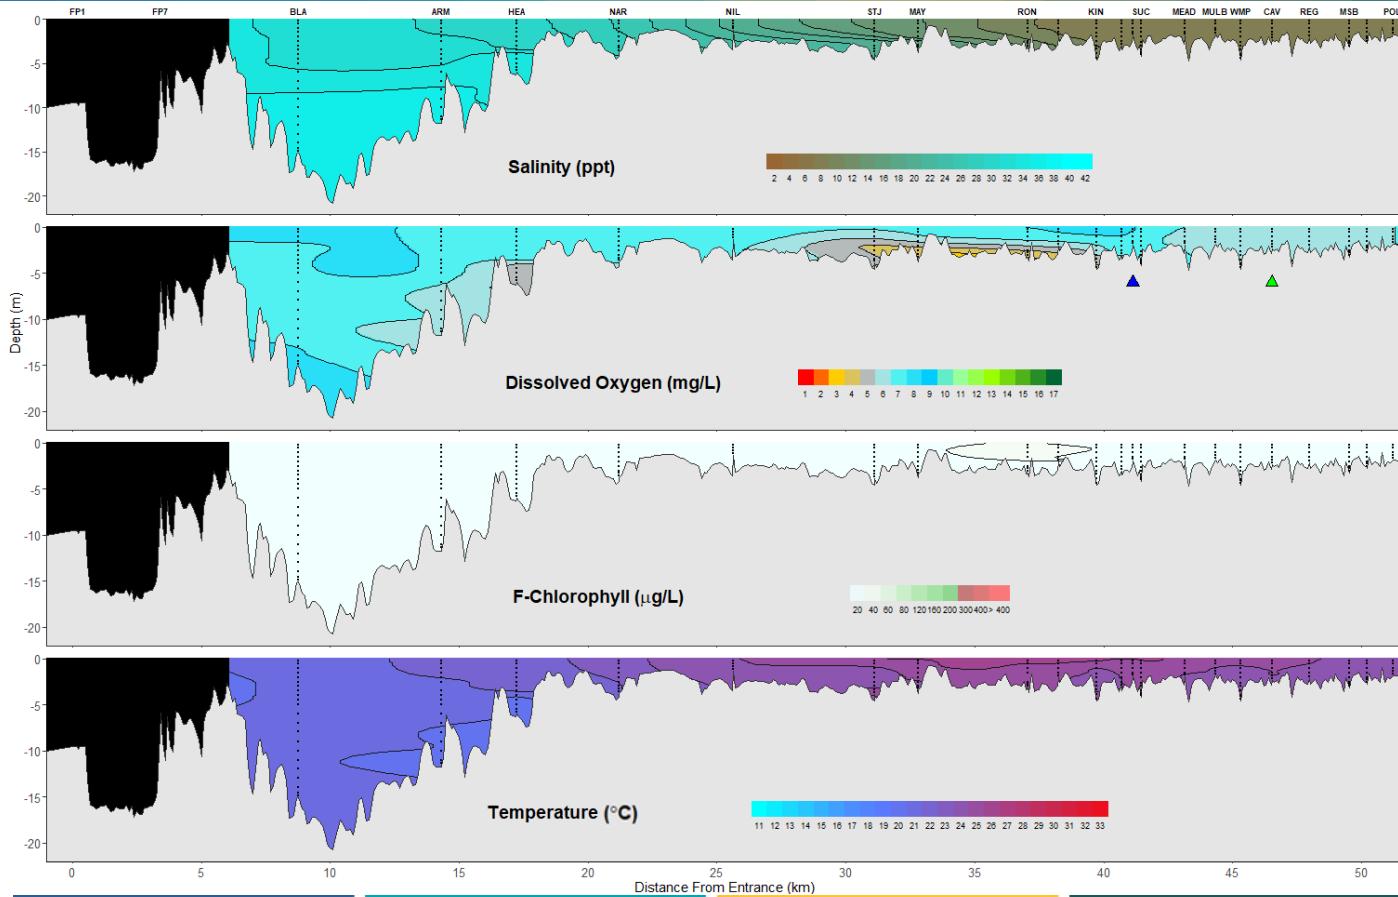
## Swan Canning Estuary - Water Quality Profiles - 28<sup>th</sup> November 2022

Lower Swan Canning Estuary (BLA to NAR): The Lower Swan Canning Estuary was saline and waters were oxygenated or well oxygenated throughout. Chlorophyll fluorescence was low throughout and water temperature ranged from 19.7 to 22.6 °C at the time of sampling.

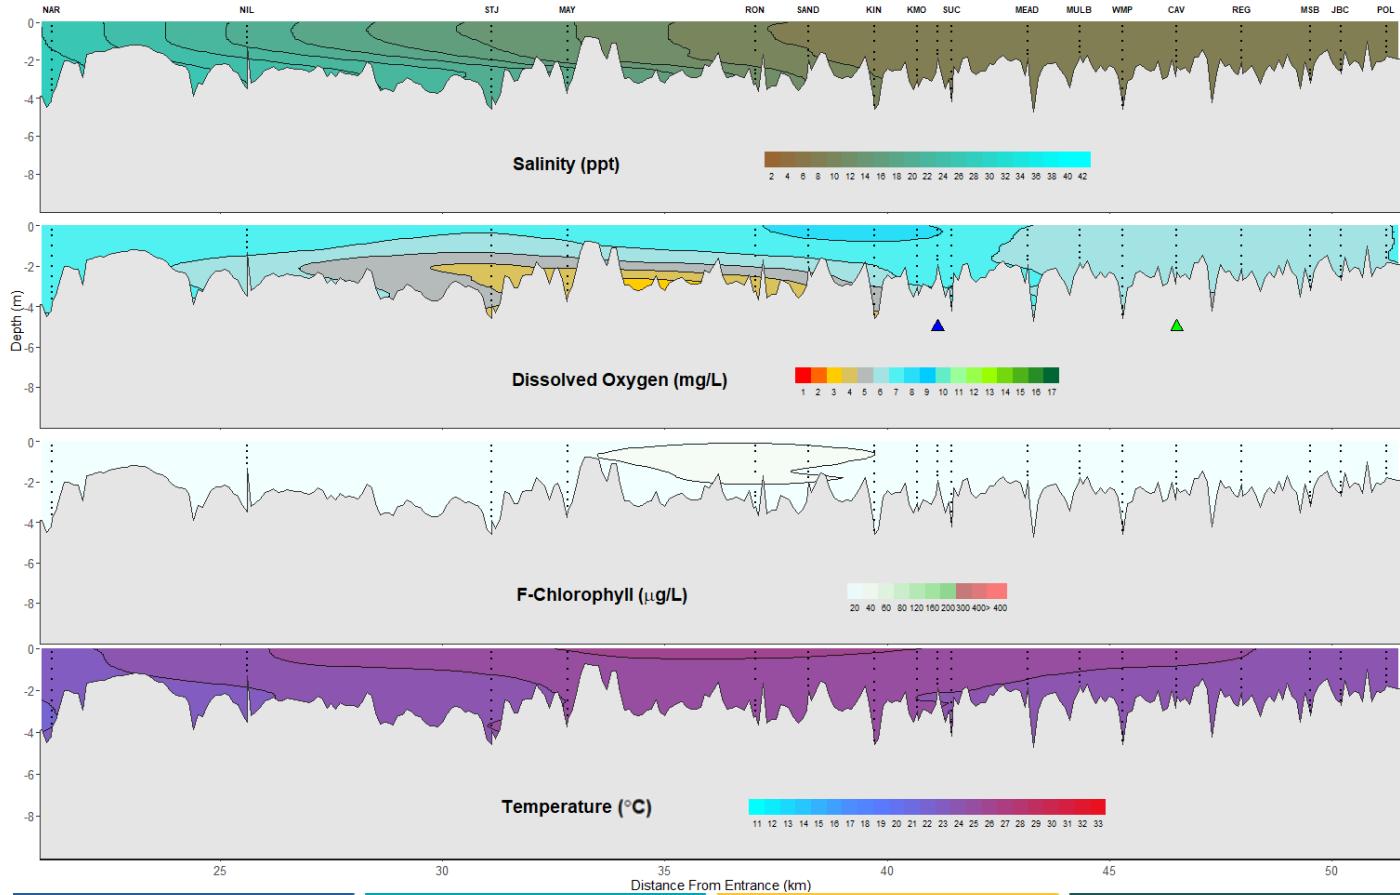
## Middle and Upper Swan Estuary - Water Quality Profiles - 28<sup>th</sup> November 2022

Middle Swan Estuary (NIL to RON): The Middle Swan Estuary was brackish and waters were oxygenated or well oxygenated, except at the bottom waters of MAY and RON, which were low in oxygen. Chlorophyll fluorescence was low throughout and water temperature ranged from 23.5 to 25.2 °C at the time of sampling.

Upper Swan Estuary (SAND to POL): The Upper Swan Estuary was brackish and waters were oxygenated or well oxygenated, except at the very bottom waters of KIN, which were low in oxygen. Chlorophyll fluorescence was low throughout and water temperature ranged from 23.2 to 25.2 °C at the time of sampling.

Oxygenation: The Guildford oxygenation plant was operable but not triggered to provide oxygen during the 24 hours prior to sampling, and the Caversham oxygenation plant was operable and provided oxygen in the 24 hours prior to sampling.
