# Swan Canning Estuary Water Quality Monitoring Project

## Weekly Water Quality Report

### Lower Swan Canning Estuary to Upper Swan Estuary

15 August 2022

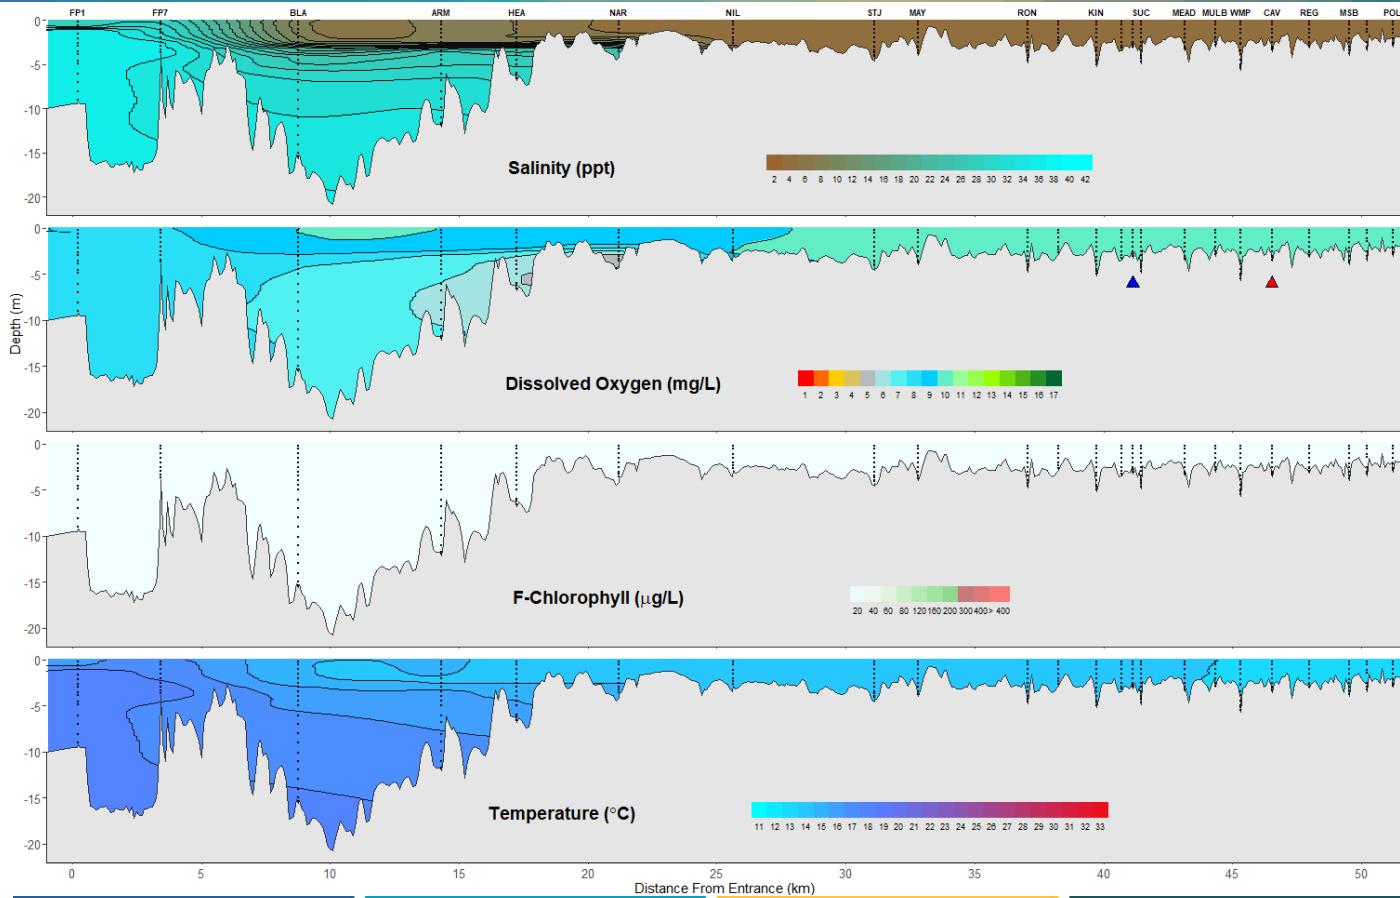
## Swan Canning Estuary- Water Quality Profiles – 15 August 2022

Lower Swan Canning Estuary (FP1 to NAR): The Lower Swan Canning Estuary was saline from FP1 to FP7, brackish over saline from BLA to HEA and fresh over brackish at NAR. Waters were oxygenated or well oxygenated throughout, chlorophyll fluorescence was low and water temperature ranged from 13.5 to 17.4 °C at the time of sampling.

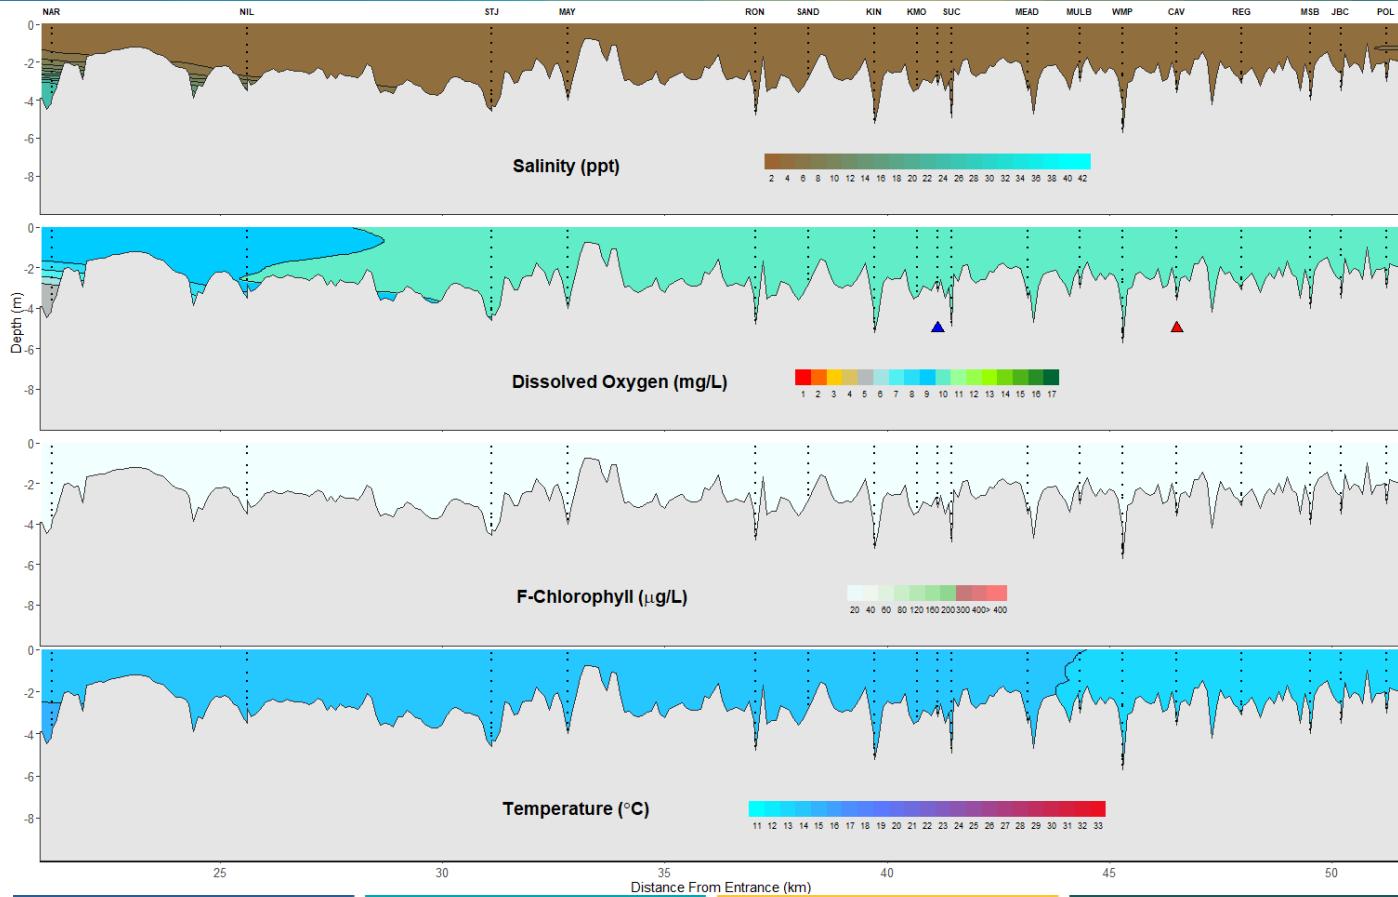
## Middle and Upper Swan Estuary- Water Quality Profiles – 15 August 2022

Middle Swan Estuary (NIL to RON): The Middle Swan Estuary was fresh and waters were well oxygenated throughout. Chlorophyll fluorescence was low and water temperature ranged from 13.1 to 13.8 °C at the time of sampling.

Upper Swan Estuary (SAND to POL): The Upper Swan Estuary was fresh and waters were well oxygenated throughout. Chlorophyll fluorescence was low and temperature ranged from 12.6 to 13.7 °C at the time of sampling.
