# Swan Canning Estuary Water Quality Monitoring Project

## Weekly Water Quality Report

### Lower Swan Canning Estuary to Upper Swan Estuary

12<sup>th</sup> December 2022

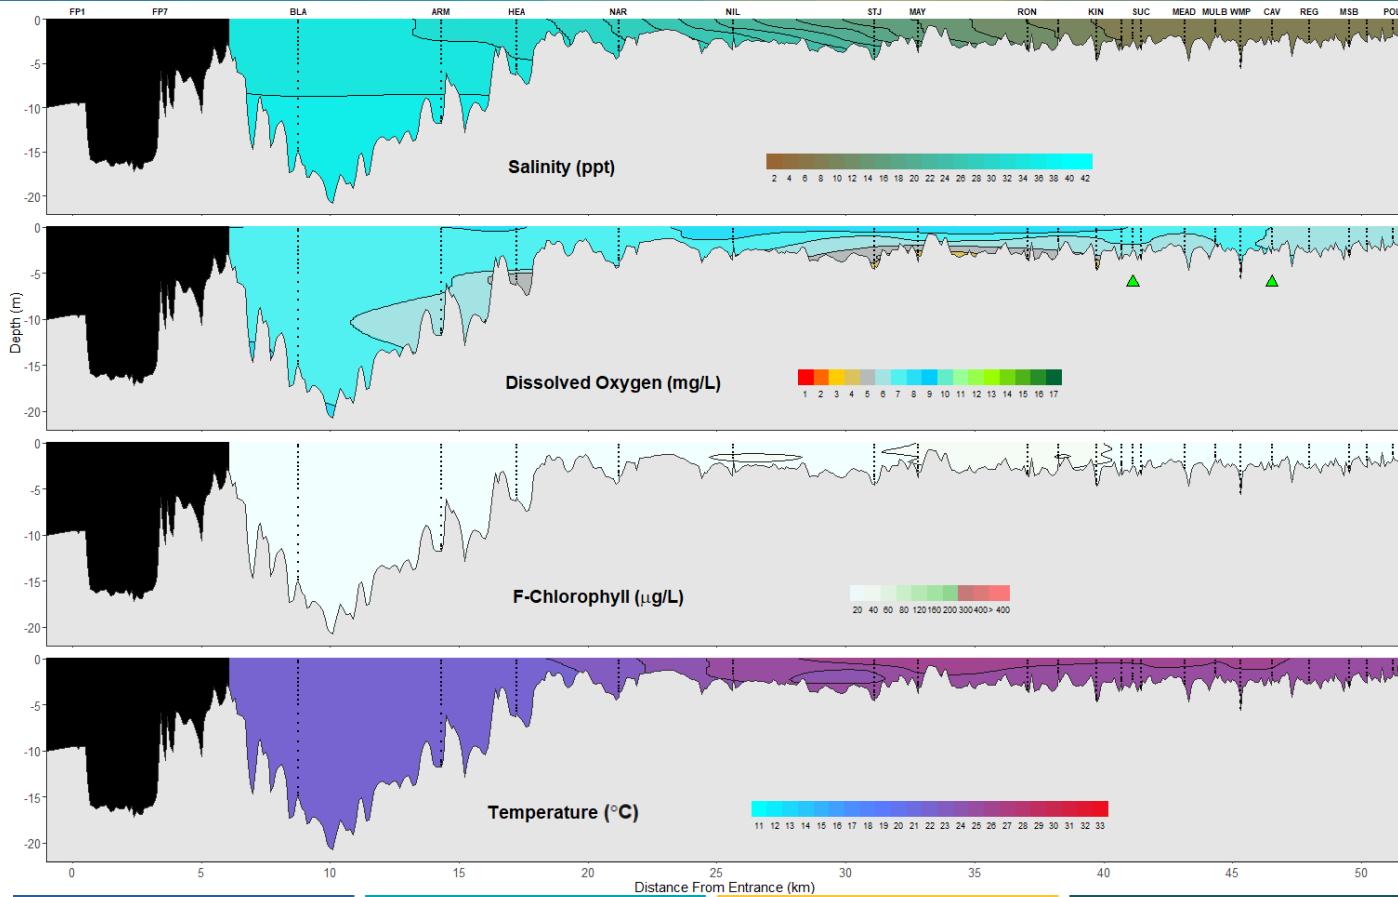
## Swan Canning Estuary - Water Quality Profiles - 12<sup>th</sup> December 2022

Lower Swan Canning Estuary (BLA to NAR): The Lower Swan Canning Estuary was saline and waters were oxygenated or well oxygenated throughout. Chlorophyll fluorescence was low throughout and water temperature ranged from 21.1 to 22.7 °C at the time of sampling.

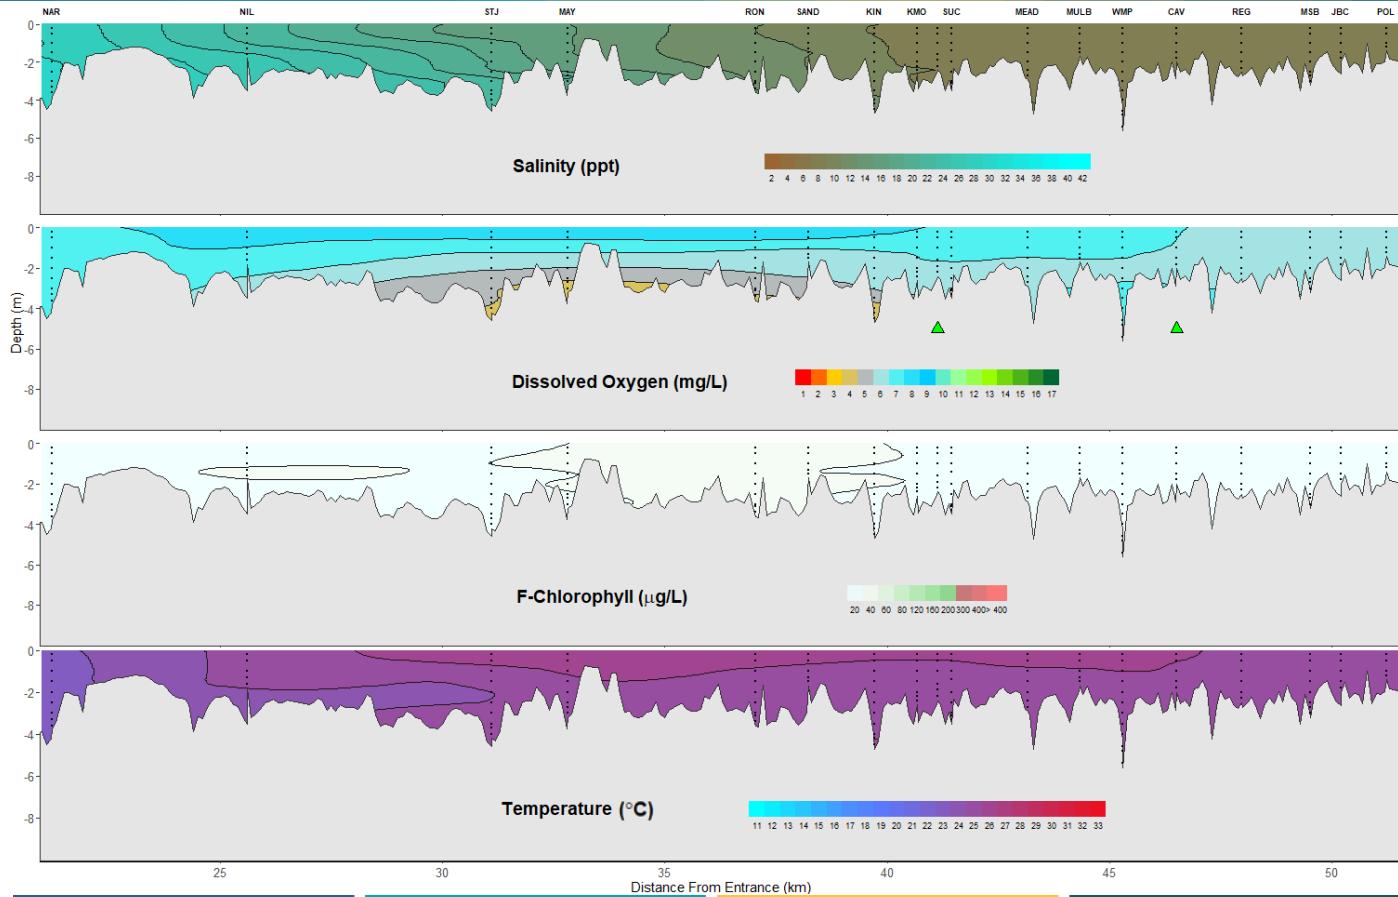
## Middle and Upper Swan Estuary - Water Quality Profiles - 12<sup>th</sup> December 2022

Middle Swan Estuary (NIL to RON): The Middle Swan Estuary was brackish and waters were oxygenated or well oxygenated, except at the bottom waters of STJ and MAY, which were low in oxygen. Chlorophyll fluorescence was low throughout and water temperature ranged from 23.9 to 25.6 °C at the time of sampling.

Upper Swan Estuary (SAND to POL): The Upper Swan Estuary was brackish and waters were oxygenated or well oxygenated, except at the very bottom waters of KIN, which were low in oxygen. Chlorophyll fluorescence was low throughout and water temperature ranged from 24 to 25.6 °C at the time of sampling.
